**MERRIMACK RIVER BASIN
BRISTOL, NEW HAMPSHIRE**

**NEWFOUND LAKE DAM
NH 00137**

**PHASE I INSPECTION REPORT
NATIONAL DAM INSPECTION PROGRAM**

OCTOBER 1978

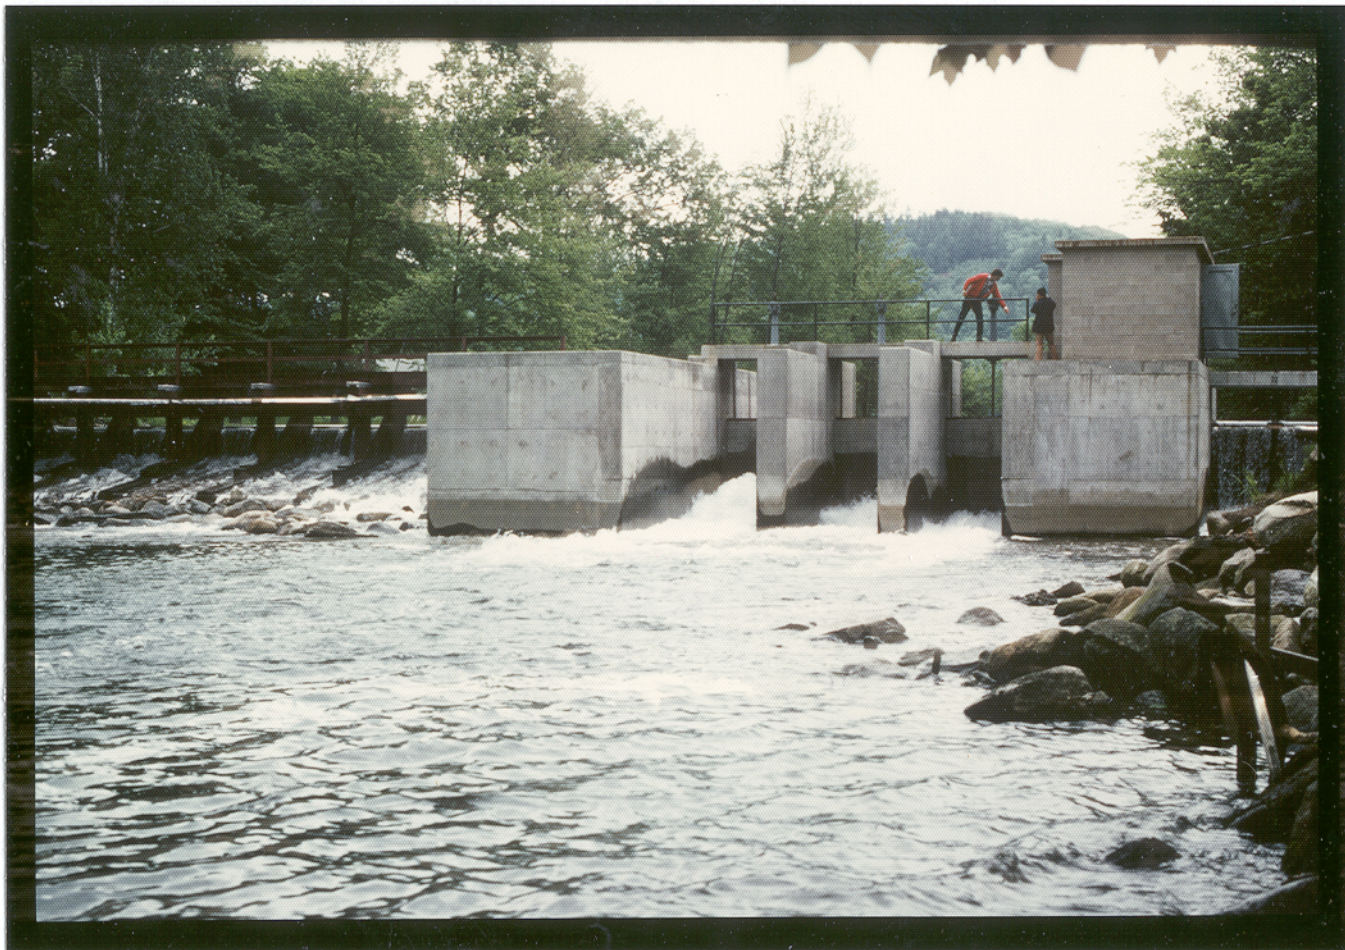
NEWFOUND LAKE DAM

General view of the dam from downstream

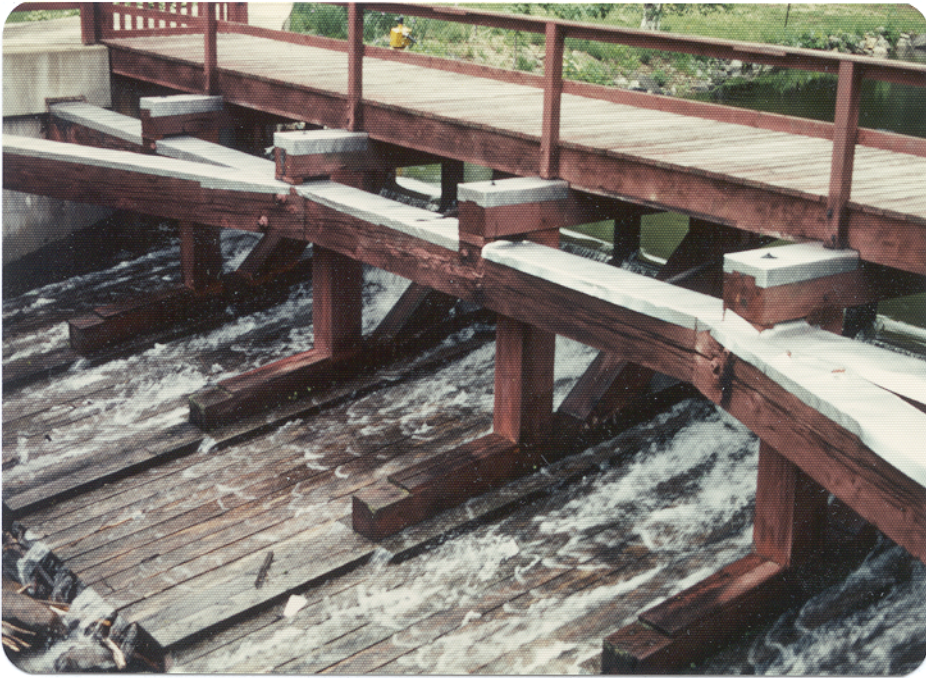
VISUAL EXAMINATION OF	OBSERVATIONS	REMARKS AND RECOMMENDATIONS
GENERAL CONDITION	The timber dam on the right abutment seemed in good serviceable condition. Main brace timbers are in sound condition and have top surfaces protected by sheet metal against excessive wetting. Timber dam has 6 8-foot wide bays each accommodating 2 stop plank passes.	No action required.
FOUNDATION	The foundation is apparently a timber crib. The floor of the timber dam section is timber and is continuously wetted. Timber condition appeared good. Cutoff and crib timber not visible.	No action required.
STOP PLANKS	All stop planks were in place and appeared to be in sound condition. Some stop planks are not tightly butted against each other permitting leakage between sections.	No action required.
DISCHARGE CHANNEL & TOE PROTECTION	Irregularly placed stones at toe of timber dam section.	
BRIDGE	A wooden walkway over the timber dam section connects the right abutment to the adjacent sluice gate section.

Photo 1 - Detailed view of the timber dam at the right abutment from downstream.

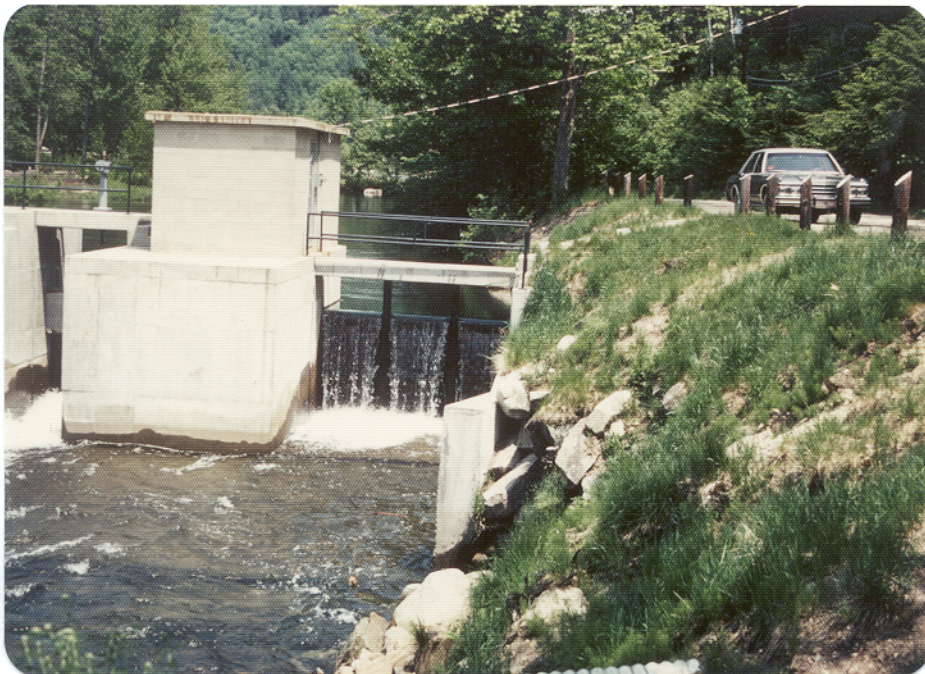
Photo 2 - View of the 6 ft. x 6 ft. sluice gate passage, gate access house and the new stop plank section on left abutment of the dam looking from downstream.

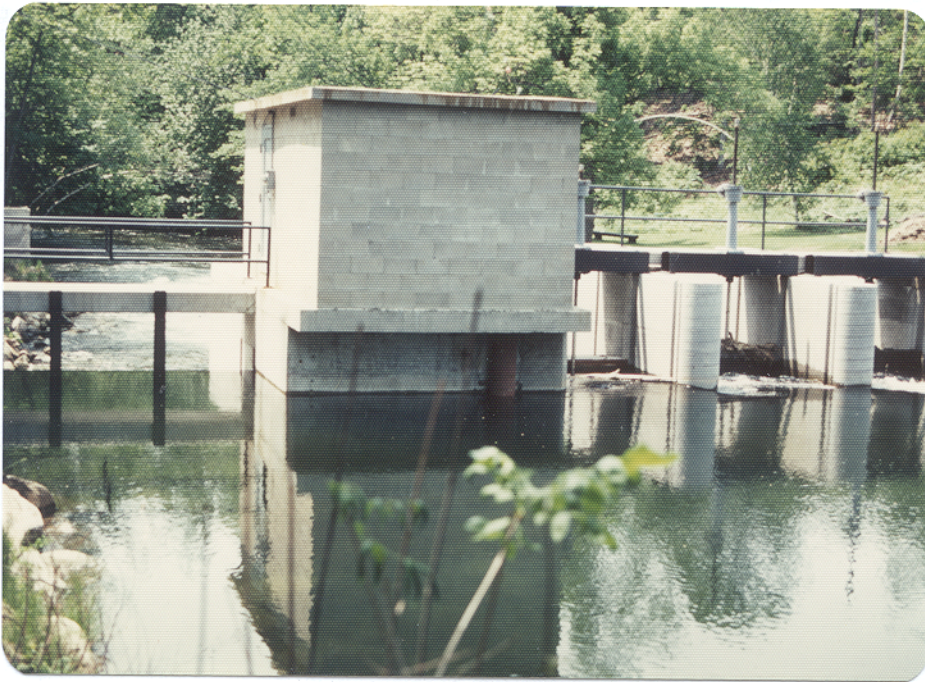
Photo 3 - View of the sluice gate section, the gate access house and the new stop plank section from upstream.

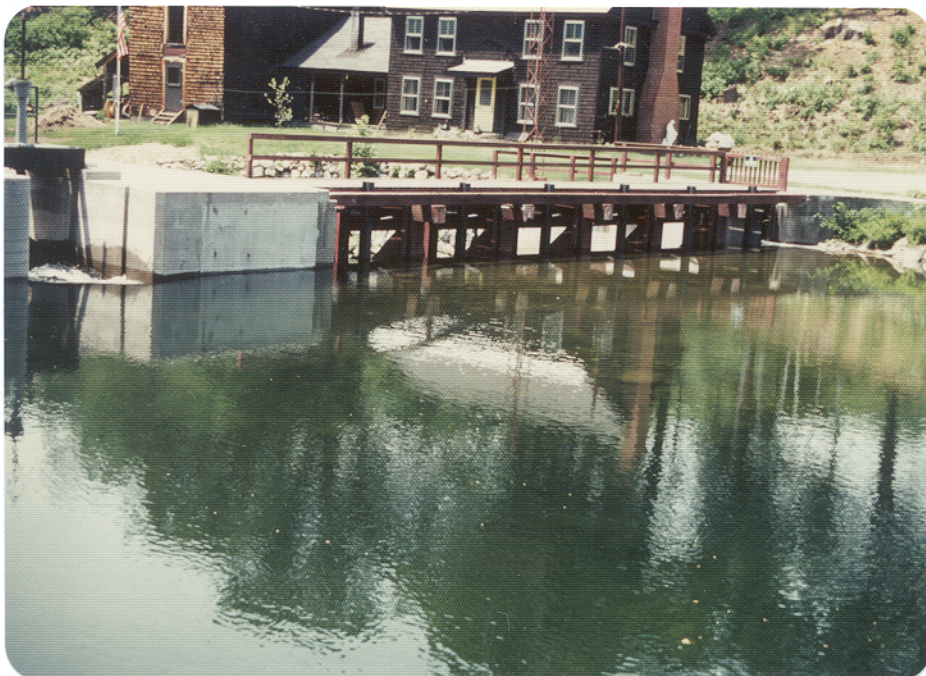
Photo 4 - View of the timber dam section and the right abutment from the upstream side.

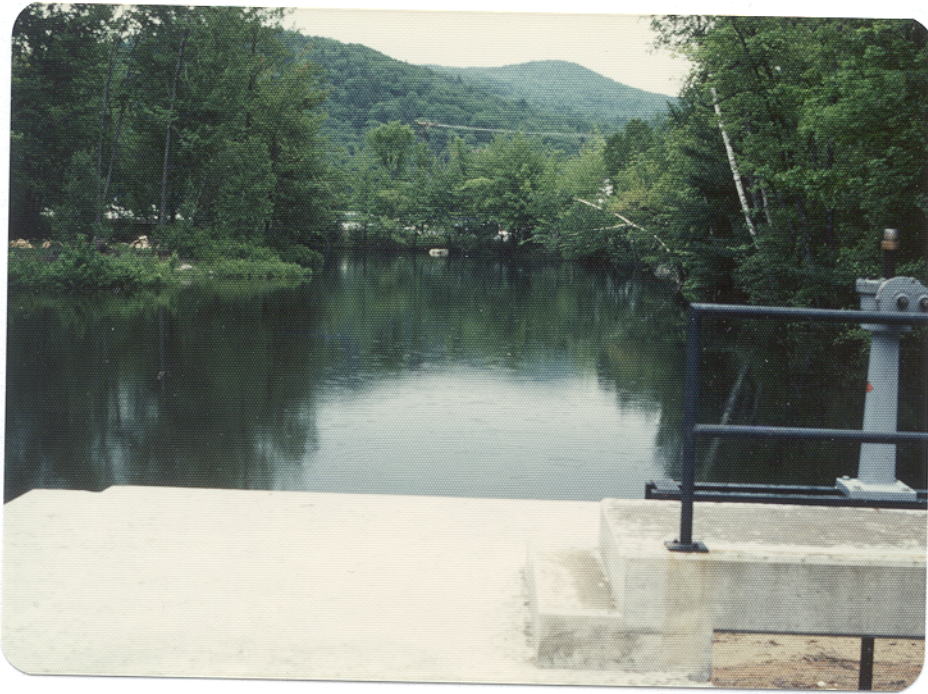
Photo 5 - View of the approach channel of Newfound River from the dam. The dam is located approximately 500 ft. downstream of the natural outlet of Newfound Lake. Note the sludge gate hoist stand in the foreground.

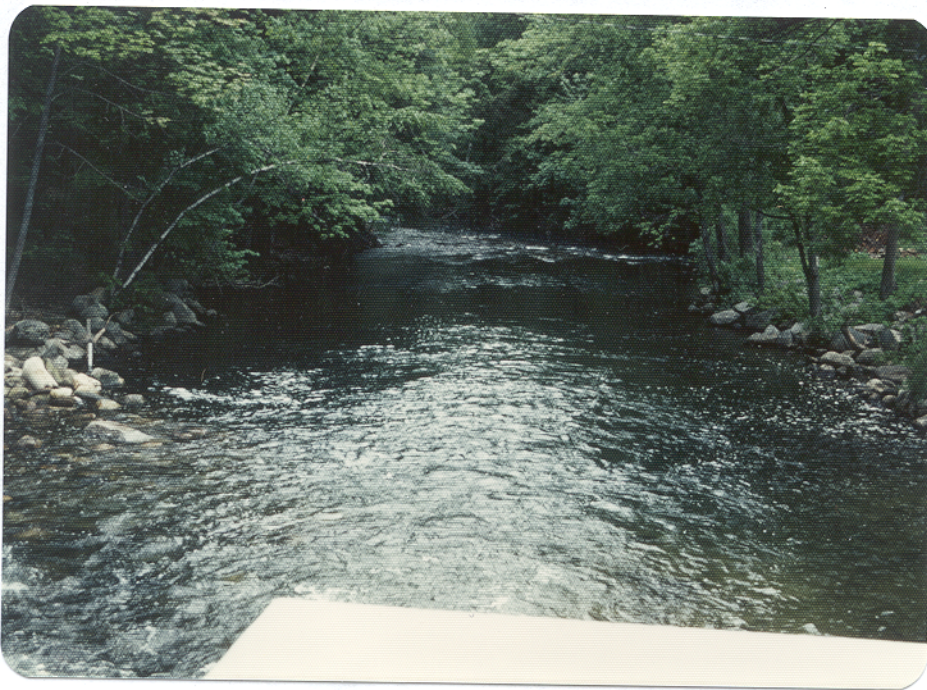
The downstream channel is well defined, unobstructed and at a moderately steep hydraulic slope. The stream banks are 6 to 8-foot high immediately downstream of the dam and have slopes of 1 on 2 horizontal. Riprap placed along the right channel side downstream of the dam is in good condition and the riprap protection on the downstream left bank is in acceptable condition. There is a power generating dam downstream of Newfound Lake Dam in current use.

Photo 6 - View of the downstream channel of Newfound River taken from the dam.
